**Montgomery
Soil & Water
Conservation
District**

**Storm Water Management &
Storm Water Pollution Prevention
City of Brookville &
Surrounding Areas**

February 27, 2018

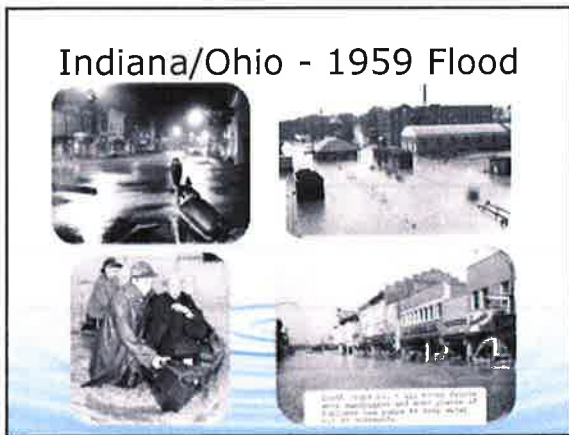
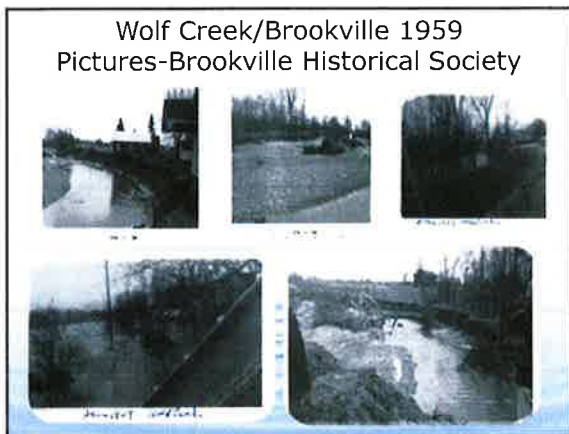
Annual Peak Discharges/Events

- Wolf Creek at Dayton USGS gauge was the only gauge that was operating during both events
- Based on that gauge:
 - The 1959 event had a discharge that was approximately 3,000cfs greater than the 2004 event
 - Produced a water surface elevation approximately 1.8 feet higher

1959 Flood
• Jan. 21, 1959
• 12,500cfs
• 755.1 Peak Elev.
2004 Flood
• May 28, 2004
• 9,420cfs
• 753.33 Peak Elev.

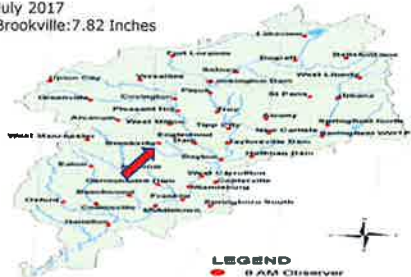
Local Rainfall-2017

July 2017
Brookville: 7.82 Inches

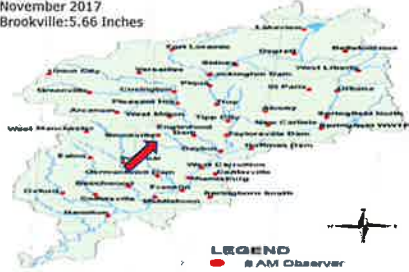
Local Rainfall-November 2017

November 2017
Brookville: 5.66 Inches

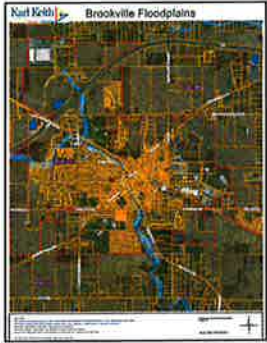
The Areas in Blue are FEMA Flood Zones-Blue on the Map

1. Will this log jam project reduce my flood insurance?-No
2. Will this keep me from carrying flood insurance?-No
3. Can I get a flood exemption certificate?- You can hire a private engineer to determine the elevation and possible exemption.
